# Evaluation of Drop-Check Structures for Farm Irrigation Systems

A. S. Humpherys

## ABSTRACT

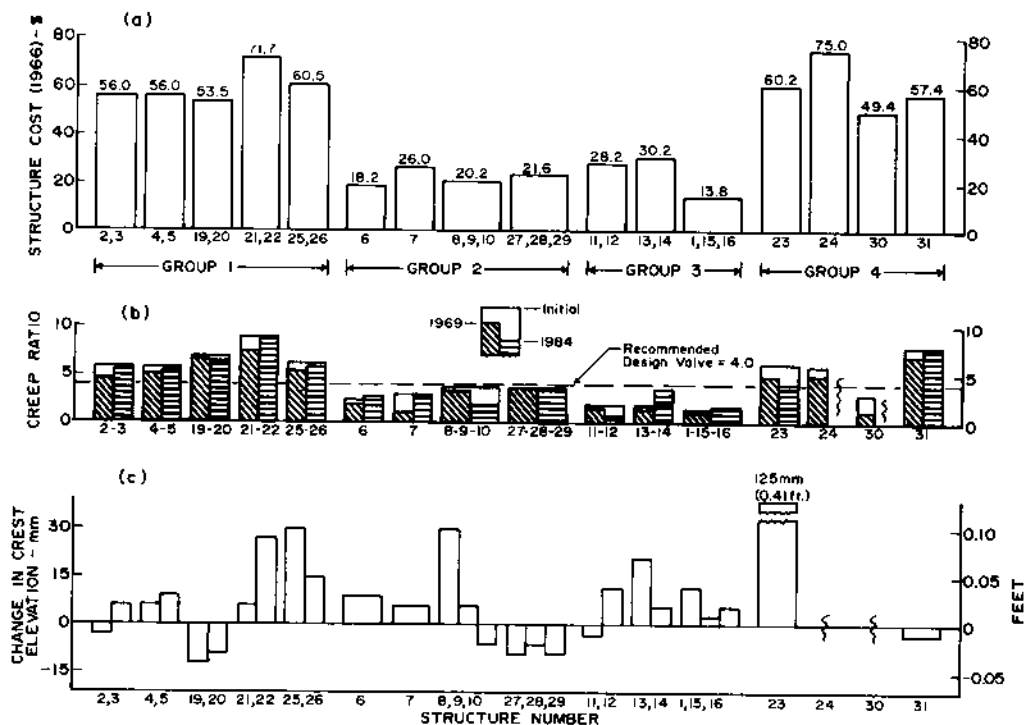
Fig. 2—(a) Structure costs, (b) changes in average creep ratios since 1969, and (c) elevation changes since 1969.

Creep ratios at the beginning of the study were the same for each structure of a pair (or trio) for a given design, and are shown graphically in Fig. 2b for a seepage head of 15 cm (6 in.). Changes in the average ratio for each pair, or structure design, from its initial value for the 1969 and 1984 evaluations are also shown in Fig. 2b. The ratios have not changed significantly since 1969, and in most cases, increased slightly because sedimentation replaced some of the soil that had eroded from around the structures earlier. As shown in Fig. 2b, all of the precast structures have low creep ratios of less than 4.0 and all but the cofferdam structures and structure No. 6 washed out at least once during the initial study period. The failures occurred early in the study by piping around the ends of the headwalls before the soil became fully consolidated and stabilized by vegetation. Much of the piping was caused by rodent holes. None of the headwalls have completely washed out since; however, water is flowing beneath the headwall of No. 12 which has lost its fiberglass stilling basin.

Changes in crest elevations since 1969 were determined to detect structure movement and are shown graphically in Fig. 2c. Approximately one-third of the structures settled while the other two-thirds were higher. There was not a consistent correlation between structure type and elevation changes. Two of the precast structures

(Nos. 8 and 13) and two of the structures with concrete block headwalls (Nos. 22 and 25) were significantly higher, 21 to 30 mm (0.8 to 1.2 in.). Prefabricated, metal structure No. 23 was quite high and apparently had experienced considerable frost heave. This increased the grade drop through the structure and partially submerged the next upstream structure (No. 22) by increasing its tailwater depth. The elevation changes are not too surprising considering the cold and variable winter temperatures that the structures were subjected to in an area where frost heave is common.

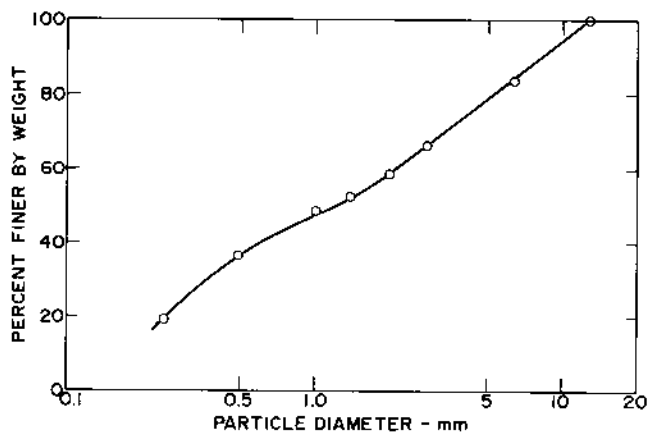
The cofferdam structures were installed with a slurry type backfill mixture of sand and fine gravel adjacent to the structure which discouraged rodent activity. However, the mixture was easily eroded by flowing water such as would occur if a structure were overtopped. The particle size distribution for this material, determined from a sample taken in 1984, is shown in Fig. 5. Since 1969, some sections of the cofferdam structures have settled and tilted such that cracks have developed between the precast sections. This has allowed water to erode the backfill material so that piping and further differential settling has occurred.

Fig. 5—Particle size distribution curve for puddled sand-gravel backfill mix used around cofferdam structures.

4. Most washout failures resulted from piping caused by rodent holes. This type failure can possibly be minimized by using a dense, puddled, clay-sand-fine gravel backfill mix to discourage rodent activity adjacent to the structure.

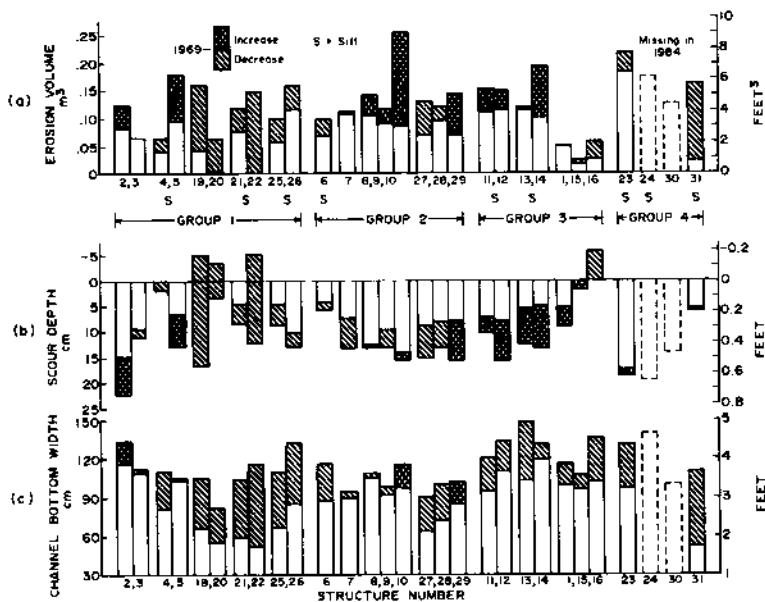
Fig. 9—Changes in (a) downstream erosion volume, (b) scour depth, and (c) channel width in 1984 compared to 1969 values for the drop/check structures tested.

short crest length which resulted in greater flow depths on the apron of structure No. 20. The superior performance of structure No. 20 with its greater tailwater depths, compared to No. 19 with shallow depths, can be seen in the erosion volumes and scour depths shown in Fig. 9a and 9b for the 1969 evaluation, before sedimentation occurred. This effect was also observed with structures 2 and 5 in 1984. A narrow piece of the checkboard in structure No. 3 was all that remained in place while the checkboard for structure No. 6 was completely missing. This lowered the upstream water surface elevations and reduced tailwater depths at structures 2 and 5. It also caused the sill of No. 5 to act as a drop. As noted in Fig. 9, both the erosion volume and scour depths increased for structures 2 and 5, which had shallow tailwater depths. This also partially explains the erosion volume and scour depth increase for structure No. 10 since the checkboard in No. 11 was also missing.

Channel cross-section measurements were made between 30 cm (6 in.) and 150 cm (30 in.) downstream from the structures. The erosion volume in 1969 and volume changes since 1969 (the volume of soil eroded from or added to the measured channel section) are shown graphically in Fig. 9a. Average scour depths and channel widths in 1969 and subsequent changes to 1984 are shown in Fig. 9b and 9c. Because of smaller average stream sizes and poor channel maintenance, sedimentation occurred in the lower ditch section between structures 19 and 31. Thus, the erosion volume and channel widths below these structures were generally less than in 1969. Erosion downstream from structure No. 29 increased because of high exit velocities which were aggravated by the sidewalls which sloughed into the ditch and contracted the flow. Scour depths generally decreased in the downstream section and were variable in the upstream section. It was difficult to relate structure performance to the 1984 channel cross section
